alkali-aggregate reaction

Definition

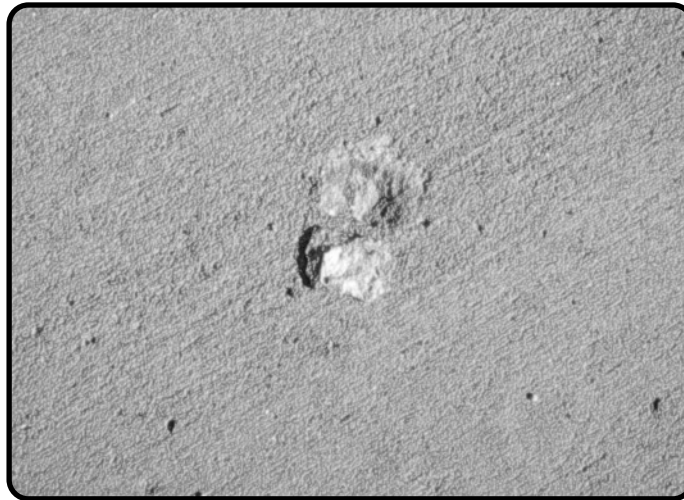
Adhere to the correct timing sequence when finishing. Do not begin any finishing operation while there is excess moisture or bleed water on the surface. Such action would only aggravate the concentration of alkalis at the surface.
